# Understanding the Bigger Picture: Interpretation of Geological Structure in Open Pit Rock Slope Stability

**R.C. Oldcorn** *MWH, New Zealand*

**R.D. Seago** *SRK Consulting, UK*

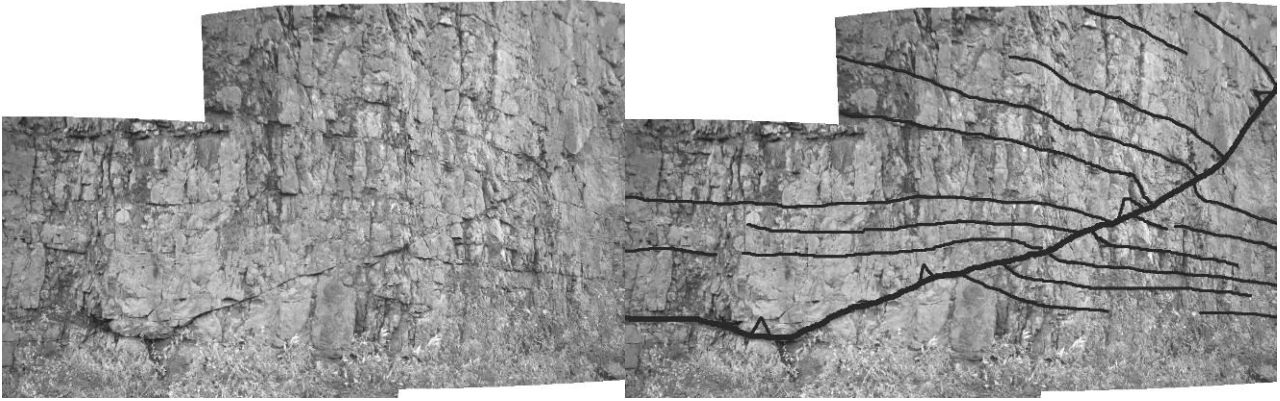
**Figure 10** Close-up of lateral ramp in South Wall of quarry. Movement is to the south and into the face. Thrust dips out of the face and is parallel to bedding on the left side of the image

The main fault at the quarry is the Pen-y-Garn Thrust, which cuts the northern limb of the Castell Coch Anticline and can be traced through part of the north wall of the quarry. All other thrust faults can be considered minor in terms of structural displacement of strata but can still have a significant impact on the pit wall stability, depending on their location relative to the existing and planned slopes, and also depending on their specific geotechnical characteristics. Other structures consistent with the folding and the low angle listric shaped faults, which become bed parallel with depth are common and tip-folds, lateral ramps and pop-ups are present, as shown in Figures 9 and 10 below.

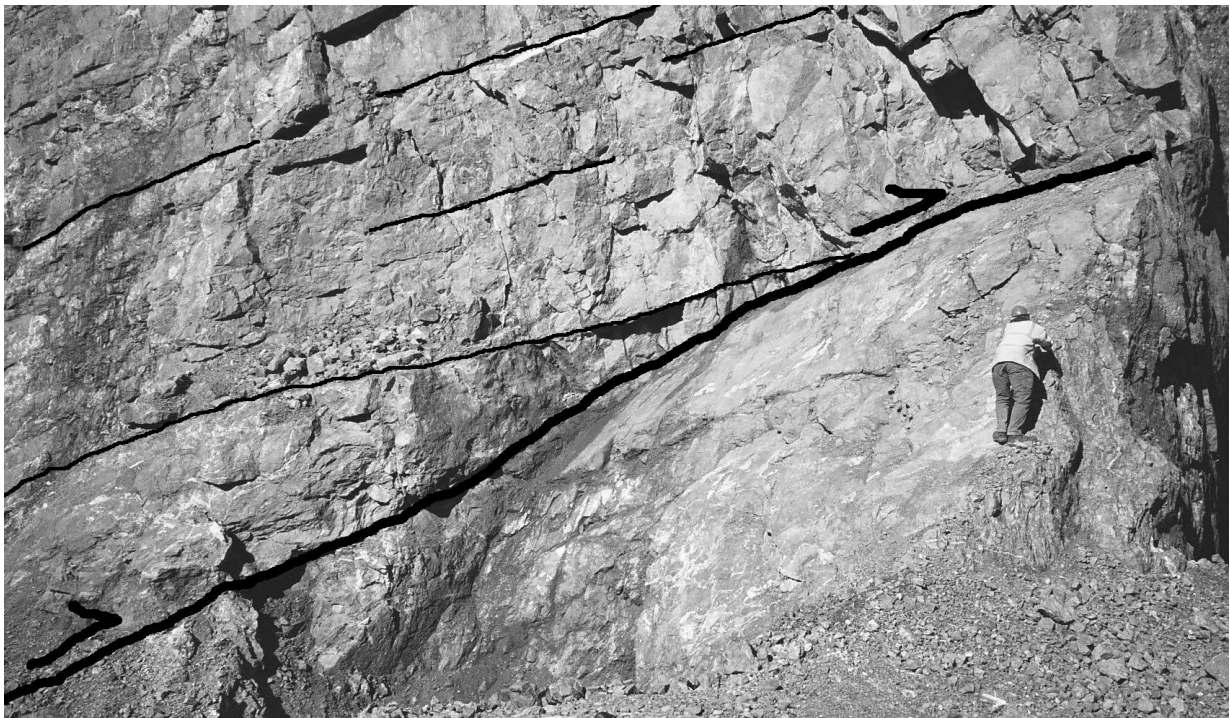
**Figure 11.** Thrust showing low angle truncation of bedding.

Because many of the thrust faults are either bedding parallel where they are exposed, or cut the bedding at very low angles, these structures are difficult to identify and the other, more obvious structures, such as the back-thrusts, pop-ups and tip folds give good supporting evidence for the style of deformation. The structures shown in Figures 9 and 10 helped define the structural model for the pit, even though they were located in a different part of the quarry that was not being developed. Figure 11 shows a situation where a thrust truncates bedding at a very low angle, its actual morphology not being immediately apparent, especially when thrusts merge into bedding and when there are zones of zero displacement further back into the limbs of the folds.

The thrust faults related to the main anticline-syncline structure of the quarry, as identified by the structural review, were of great significance to quarry planning, especially during a phase of quarry expansion and with the experience of a previous failure along the quarry wall. The structure of the quarry was oversimplified in existing models and local pit wall scale faults were not understood in sufficient detail, such as the fault shown in Figure 11.

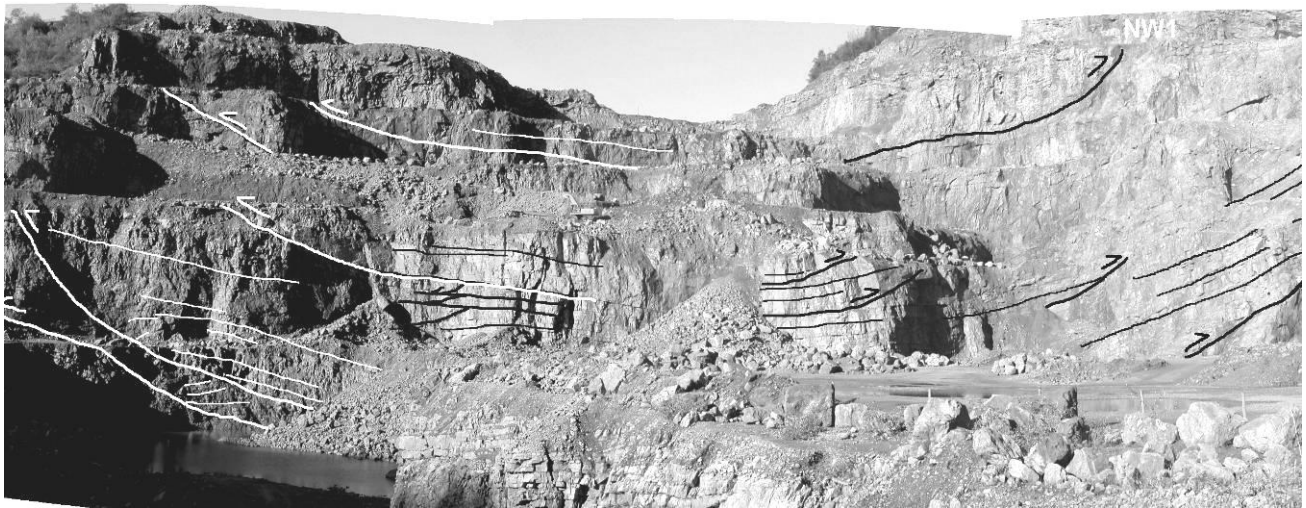
**Figure 13** Looking west at the syncline in the NW corner of the excavation, showing the presence of south dipping thrusts on the south-dipping limb and north dipping thrusts on the north-dipping limb. Arrows show the movement directions of the thrusts

Also observed in the southern limb of the Tongwynlais Syncline are numerous north dipping thrusts, which emerge from the syncline (see Figure 13). This was also extremely important for quarry planning, since development of the northwest corner of the excavation would result in north facing slopes as well as the south facing slopes in the north wall. North facing cuts would potentially expose multiple thrust faults dipping out of the slope. The configuration of these faults in this wall was the main structural control in the 2005 failure.
