# **Understanding the Bigger Picture: Interpretation of Geological Structure in Open Pit Rock Slope Stability**

Presented to: Slope Stability 07

Presented by: R.C. Oldcorn MWH, New Zealand

R.D. Seago SRK Consulting, UK

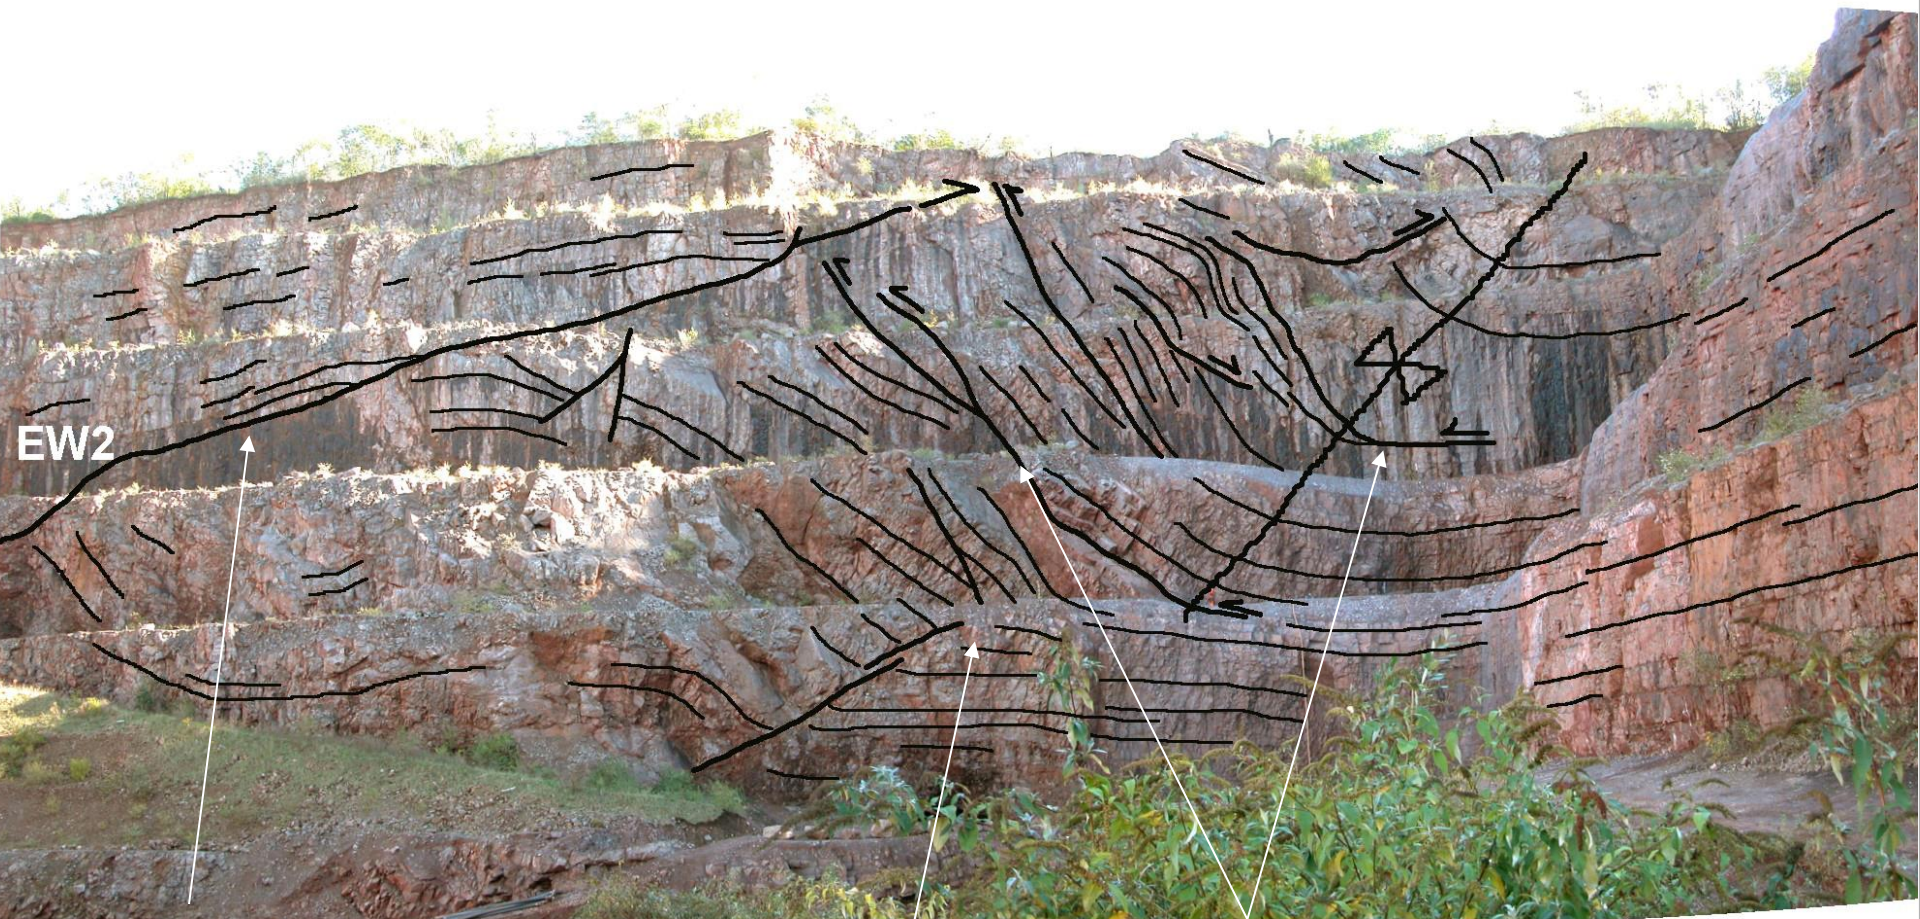
# Structural Geology in SE Corner

N-dipping  
thrust

Thrust tip dies out  
into syncline

Minor faults accommodate  
strain in folds

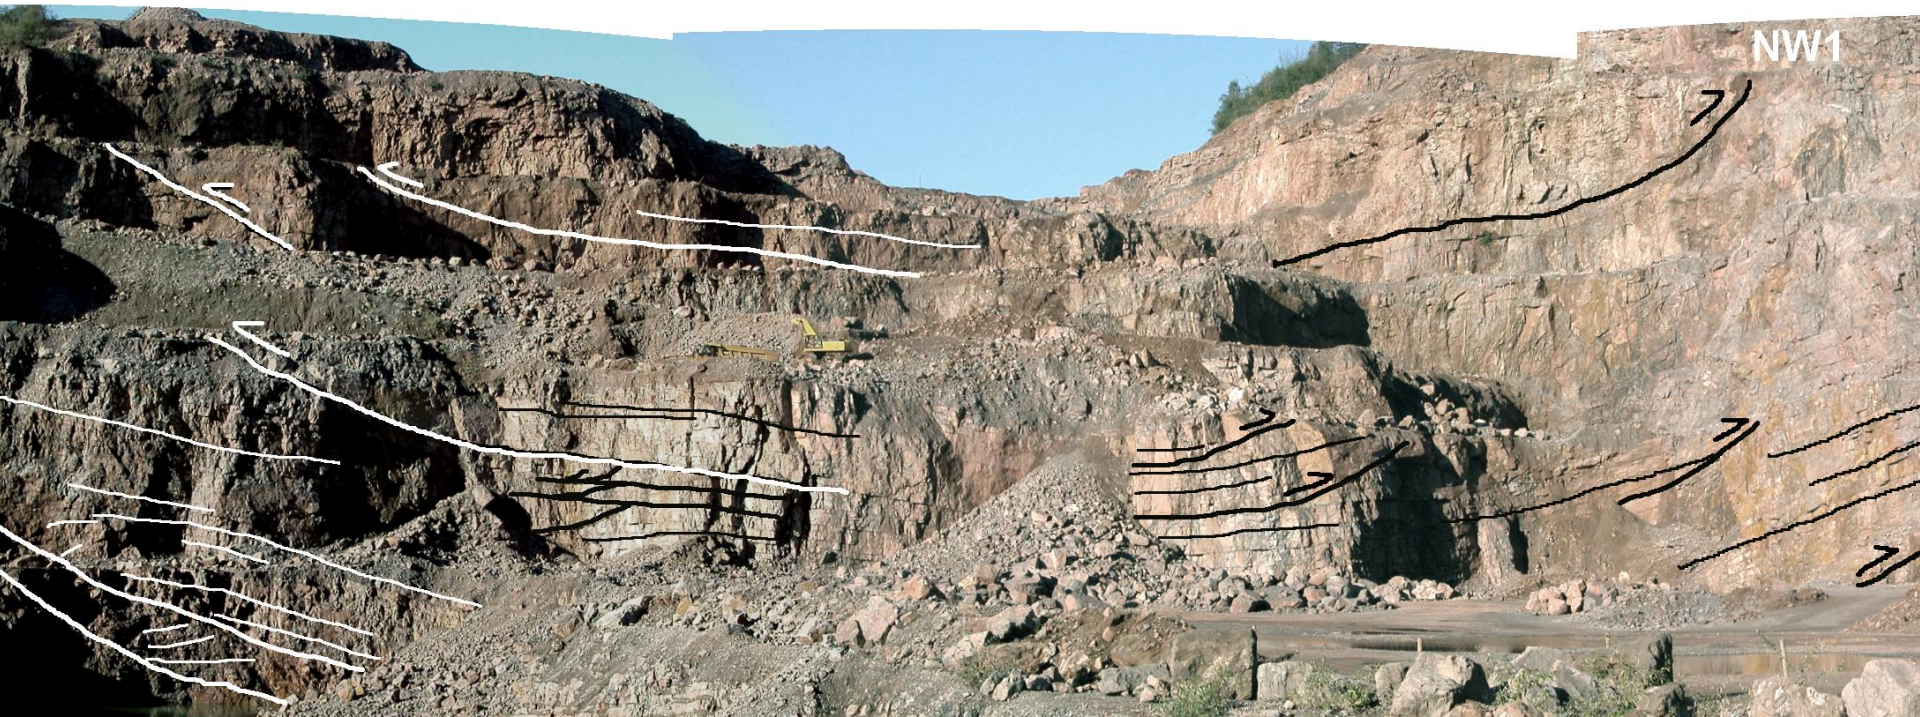
# Development in West Wall

Overall structure is a syncline which passes northwards into an anticline. Note south dipping thrusts on the south dipping limb of the syncline and north dipping thrusts on the north-dipping limb. Arrows show the movement directions of the thrusts.
